Continued Surface Water Quality Monitoring for Middle Yegua Creek, Davidson Creek and Deer Creek Watersheds Final Report

Continued Surface Water Quality Monitoring for Middle Yegua Creek, Davidson Creek, and Deer Creek Watersheds Final Report

TSSWCB Project #20-54

Characterization of Middle Yegua, Davidson, and Deer Creeks Watersheds

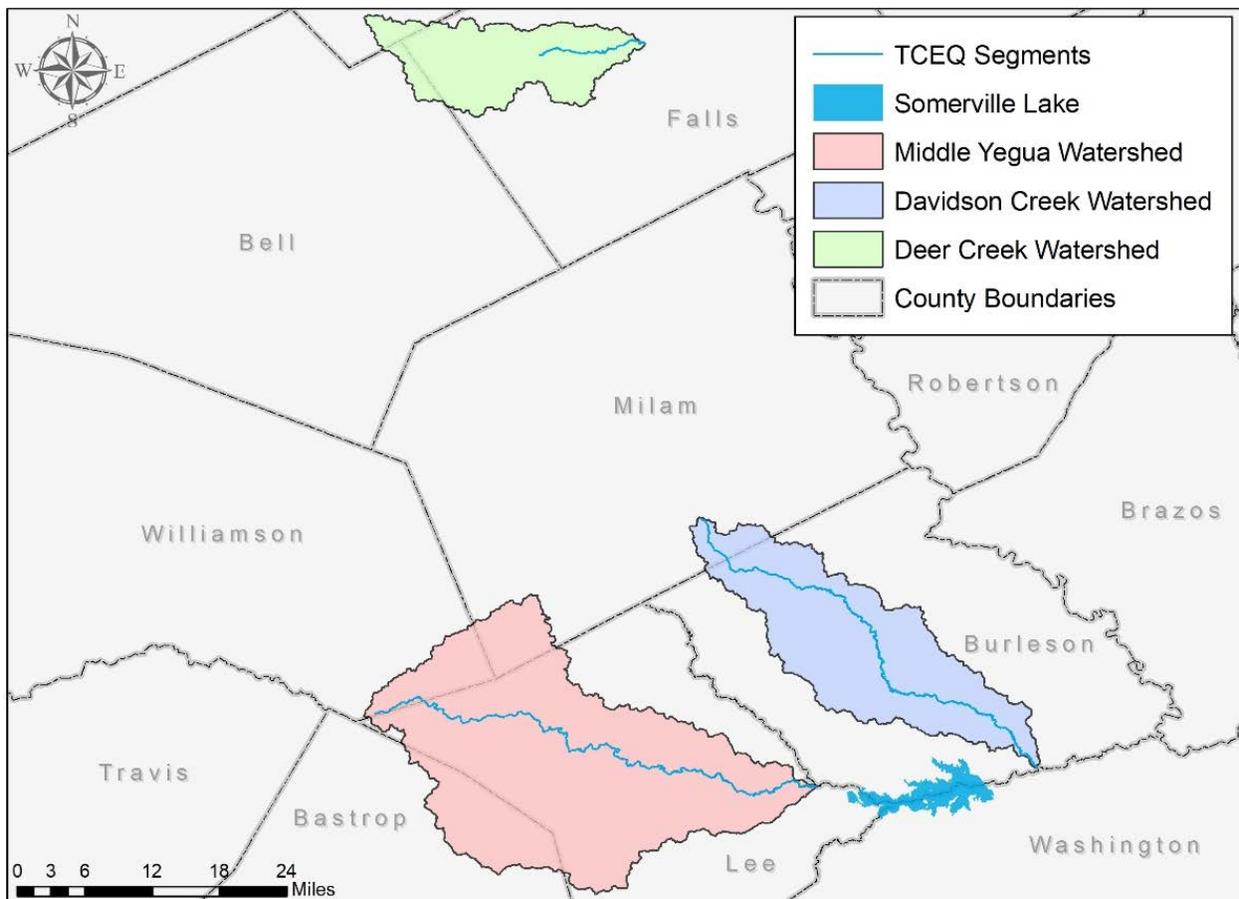
Middle Yegua Creek, Davidson Creek, and Deer Creek are all located in the southern portion of the Brazos River Basin in separate watersheds (Figure 1). Middle Yegua Creek begins at the confluence with East Yegua and Yegua creeks in Lee County and flows approximately 62 miles to the Lee County/Williamson County line. Middle Yegua Creek drains an area of approximately 440 square miles in Lee, Bastrop, Williamson, and Milam counties. Davidson Creek is an intermittent stream with perennial pools that flows approximately 59 miles from the confluence of Yegua Creek to just over 1 mile above CR 322 in Milam County. Davidson Creek drains an area of approximately 218 square miles in Burleson and Milam counties. Deer Creek is a perennial stream that begins at the confluence of the Brazos River upstream and flows approximately 11 miles to the confluence of Dog Branch northwest of Lott. Deer Creek drains an area of approximately 115 square miles in Falls, McLennan, and Bell counties. Each of the watersheds was evaluated separately throughout the project to reflect the individual characteristics and water quality issues of the waterbodies.

Figure 1. Overview of characterized watersheds.

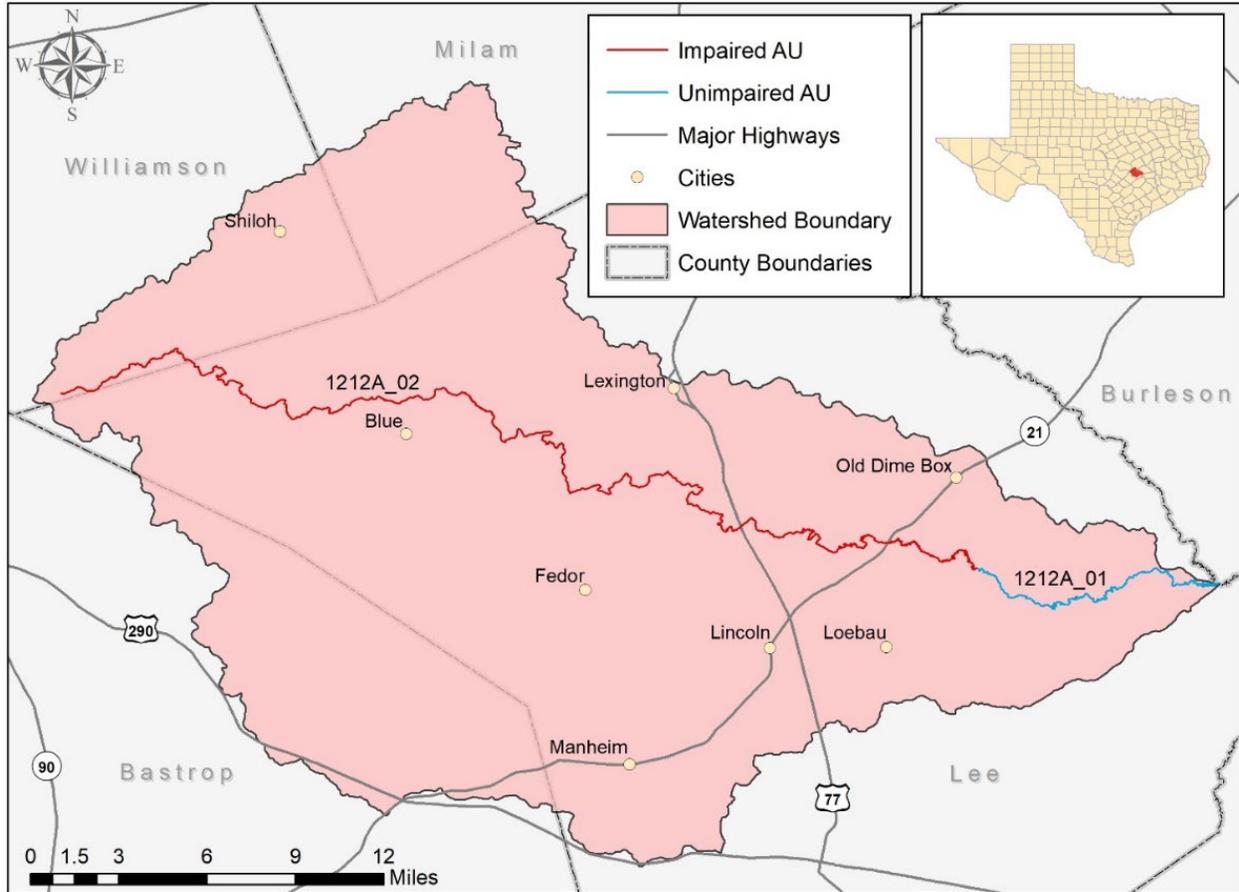
Figure 2. Middle Yegua Creek watershed with assessment units (AUs).

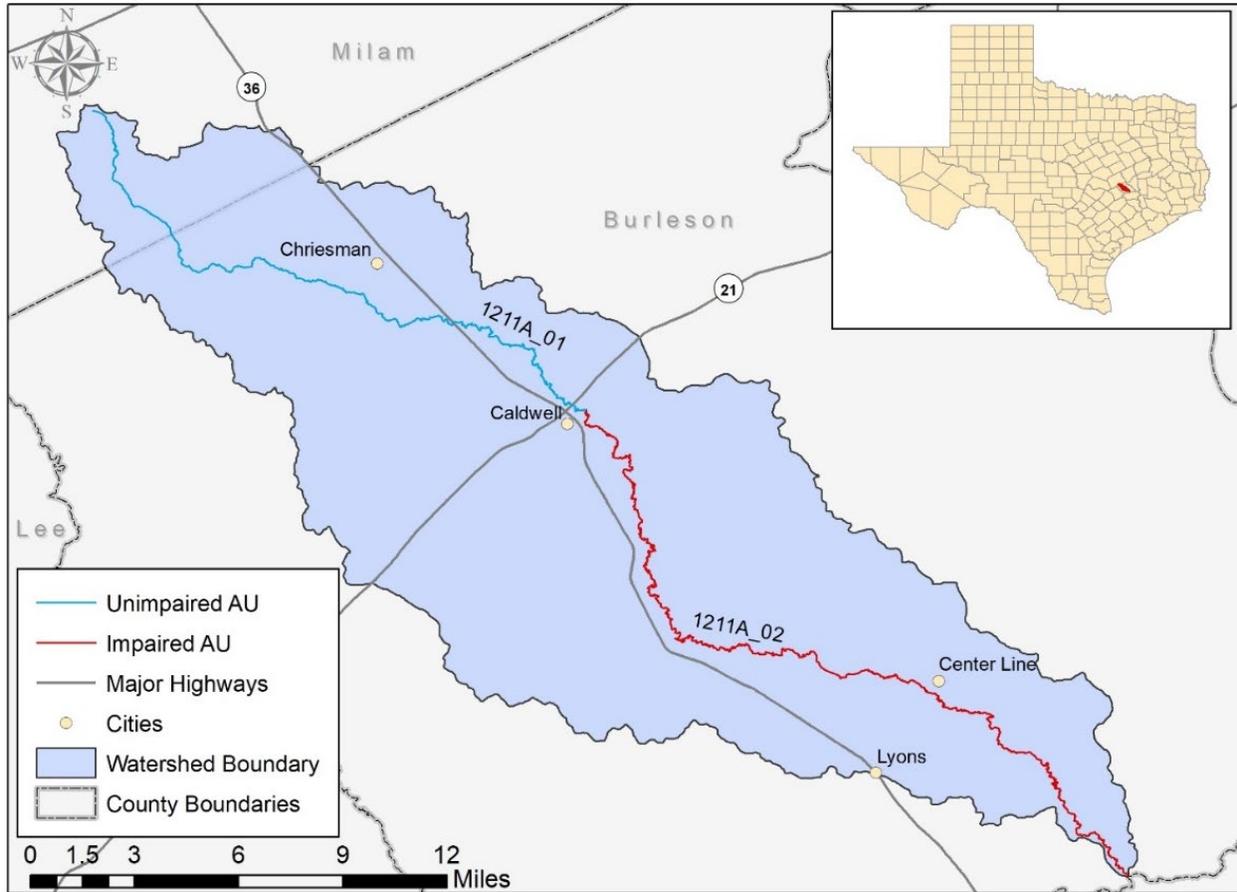
Davidson Creek (Segment ID 1211A) is an intermittent stream with perennial pools that flows approximately 59 miles from the confluence of Yegua Creek to just over 1 mile above CR 322 in Milam County (Figure 3). Davidson Creek drains an area of approximately 218 square miles in Burleson (93%) and Milam (7%) counties. The segment is also divided into two AUs, 1211A_01 and 1211A_02.

Figure 3. Davidson Creek watershed with assessment units (AUs).

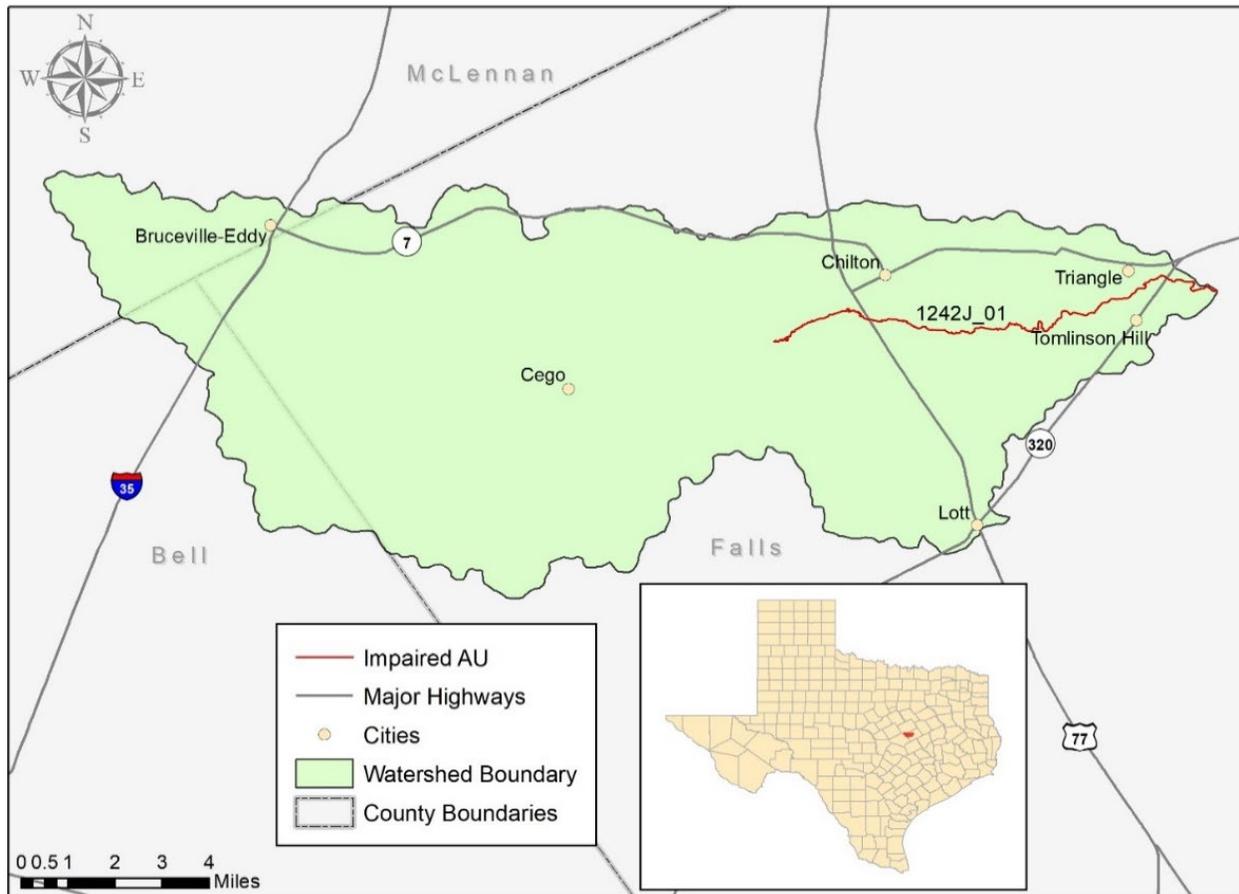
Deer Creek (Segment ID 1242J) is a perennial stream that begins at the confluence of the Brazos River upstream and flows approximately 11 miles to the confluence of Dog Branch northwest of Lott (Figure 4). Deer Creek drains an area of approximately 115 square miles in Falls (87%), McLennan (7%), and Bell (6%) counties. The segment consists of a single AU, 1242J_01.

Figure 4. Deer Creek watershed with assessment units (AUs).

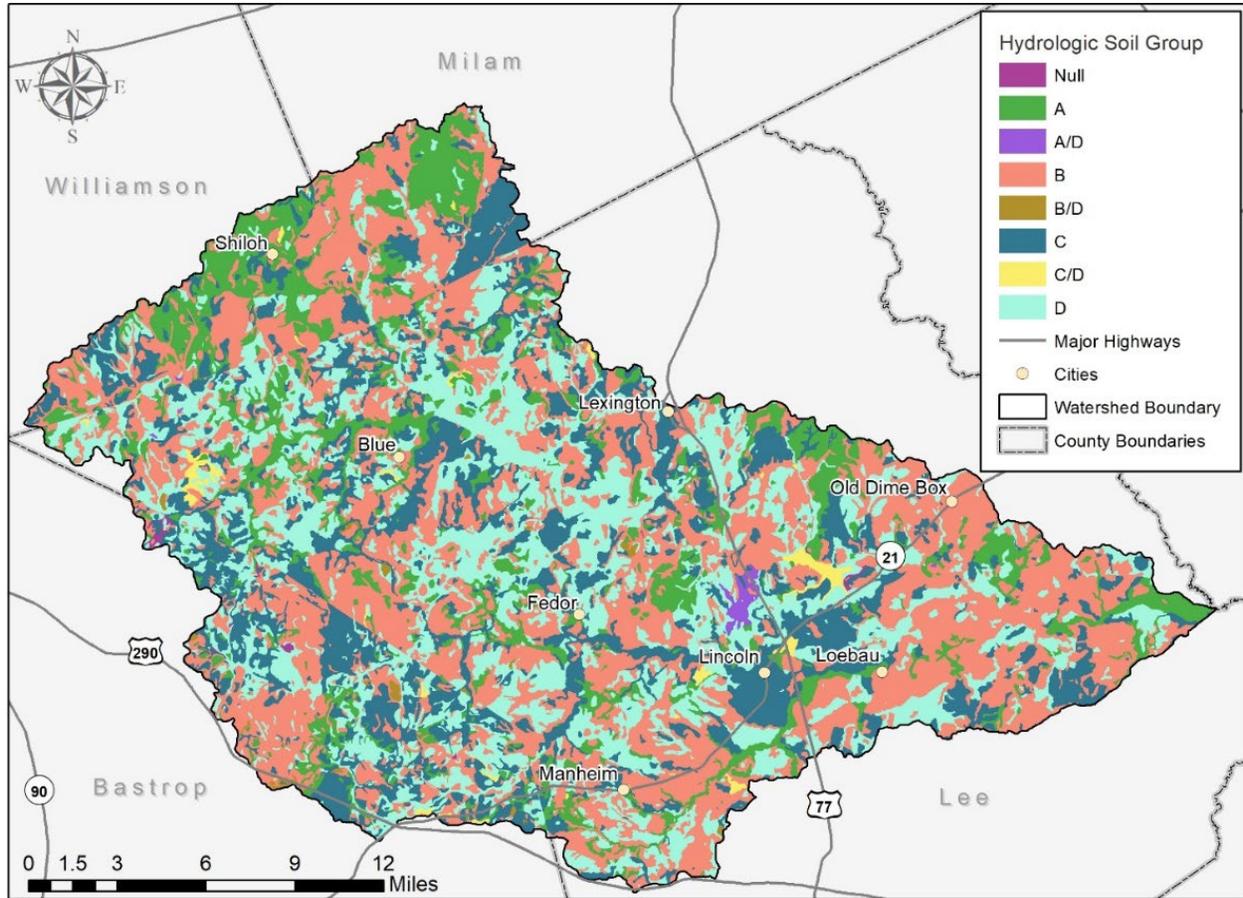
Figure 8. Middle Yegua Creek watershed hydrologic soil groups.

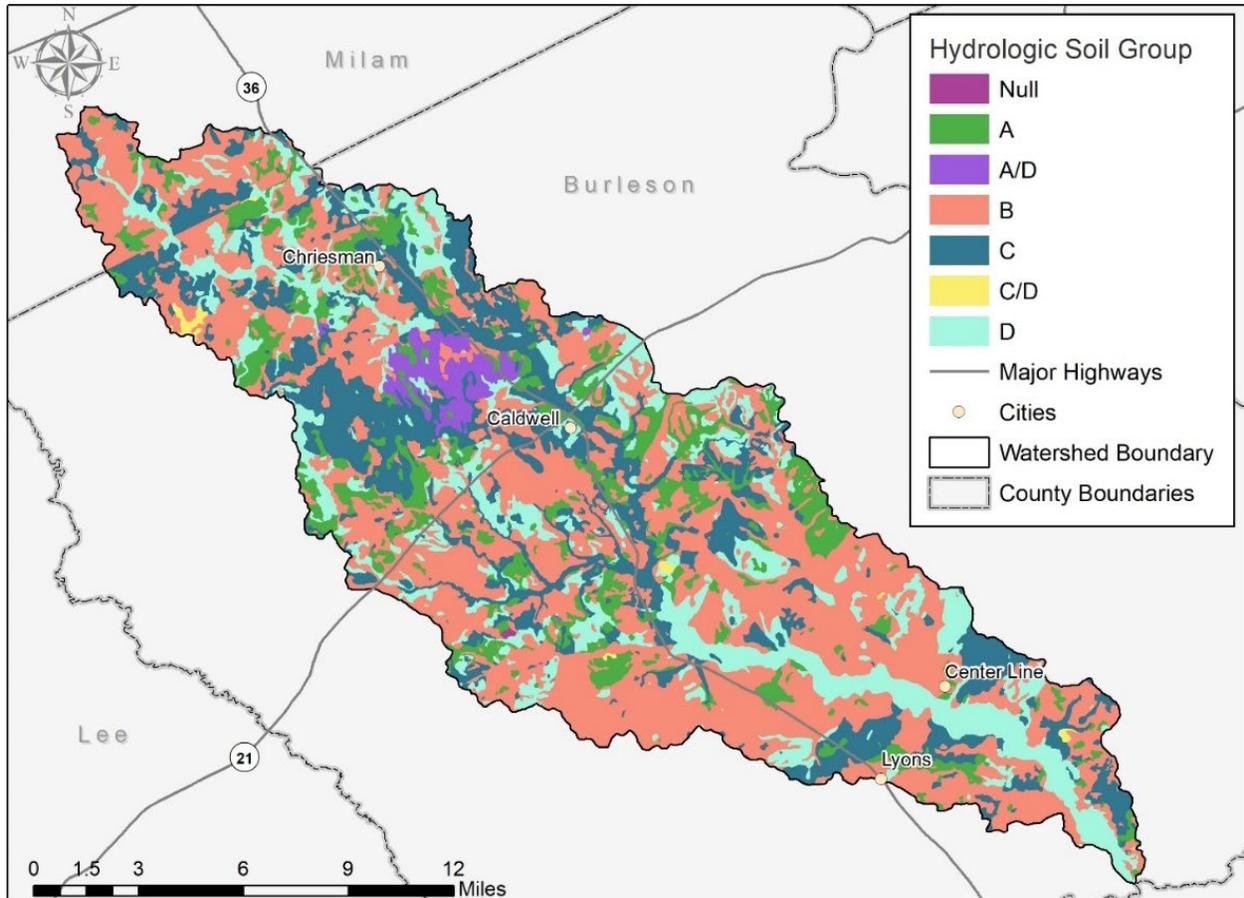
Figure 9. Davidson Creek watershed hydrologic soil groups.

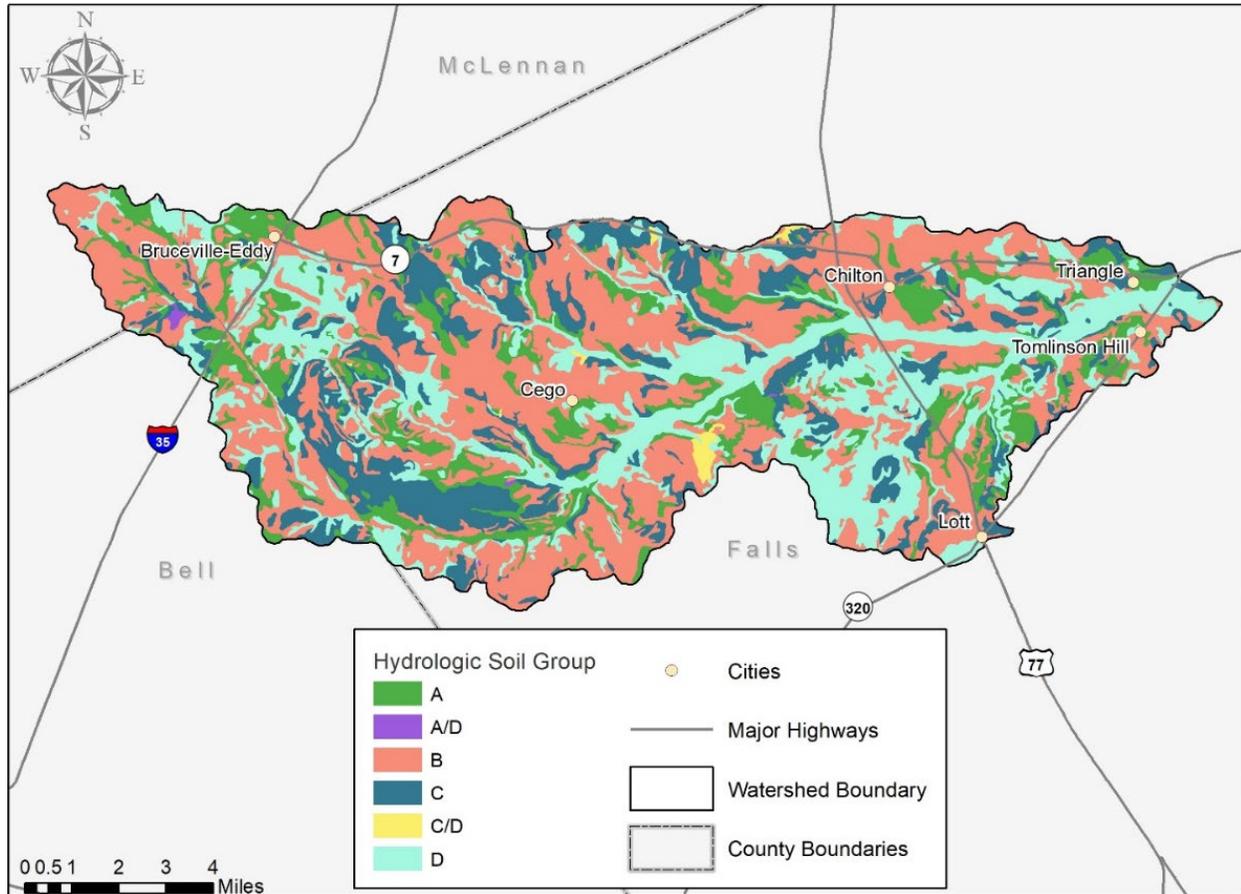
Figure 10. Deer Creek watershed hydrologic soil groups.

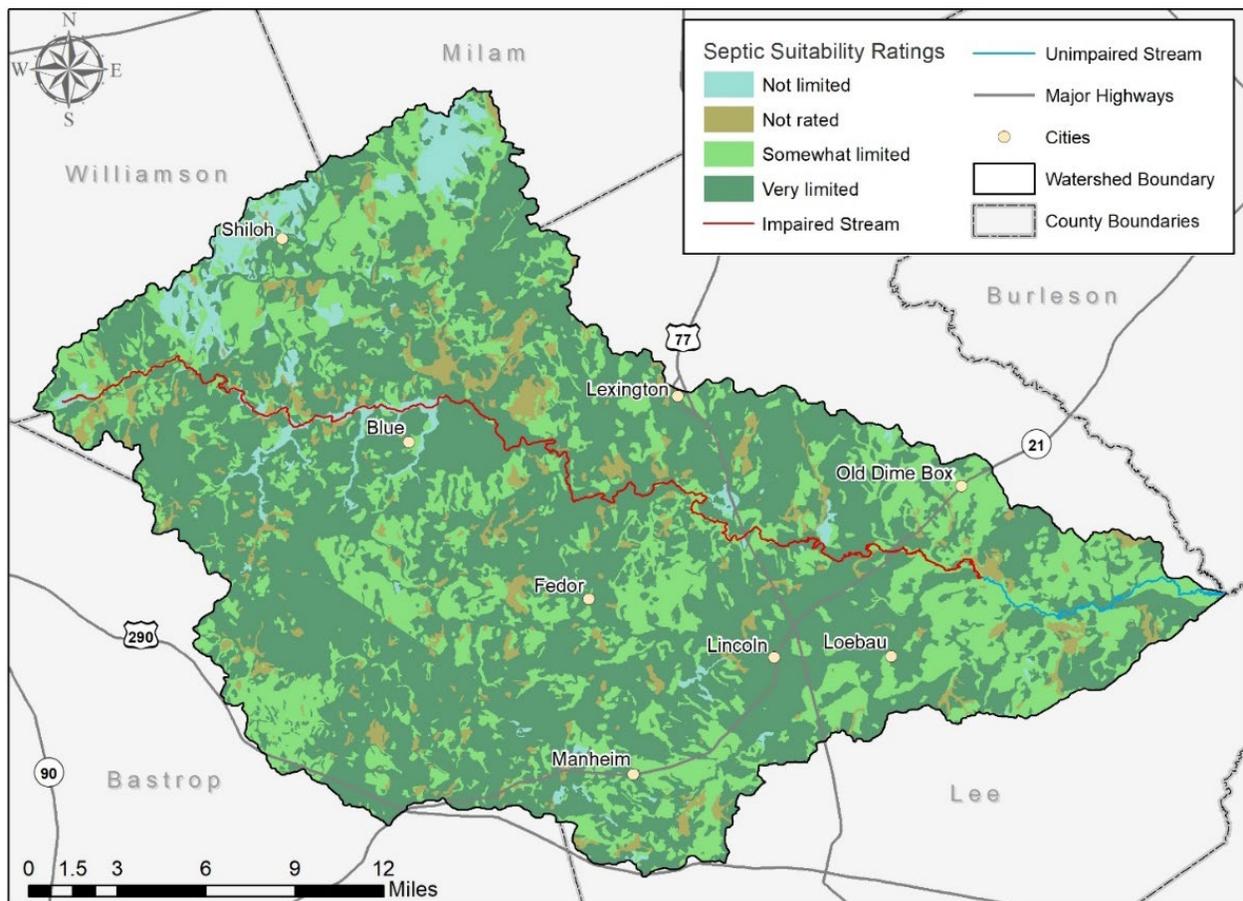
The USDA NRCS provides suitability ratings for septic tank absorption fields based on soil properties, depth to bedrock or groundwater, hydraulic conductivity, and other properties that may affect the absorption of on-site sewage facility (OSSF) effluent, installation, and maintenance. A “Not Limited” rating indicates soils with features favorable to OSSF use. “Somewhat Limited” indicates soils that are moderately favorable, with limitations that can be overcome by design, planning, and installation. “Very Limited” indicates soils that are very unfavorable for OSSF use, with expectation of poor performance and high amounts of maintenance. The majority of the soils in all three watersheds are rated “Very Limited” for OSSF use, followed by smaller areas rated “Somewhat Limited” (Figure 11, Figure 12, Figure 13; USDA 2019).

Figure 11. Middle Yegua Creek watershed on-site sewage facility adsorption field ratings.

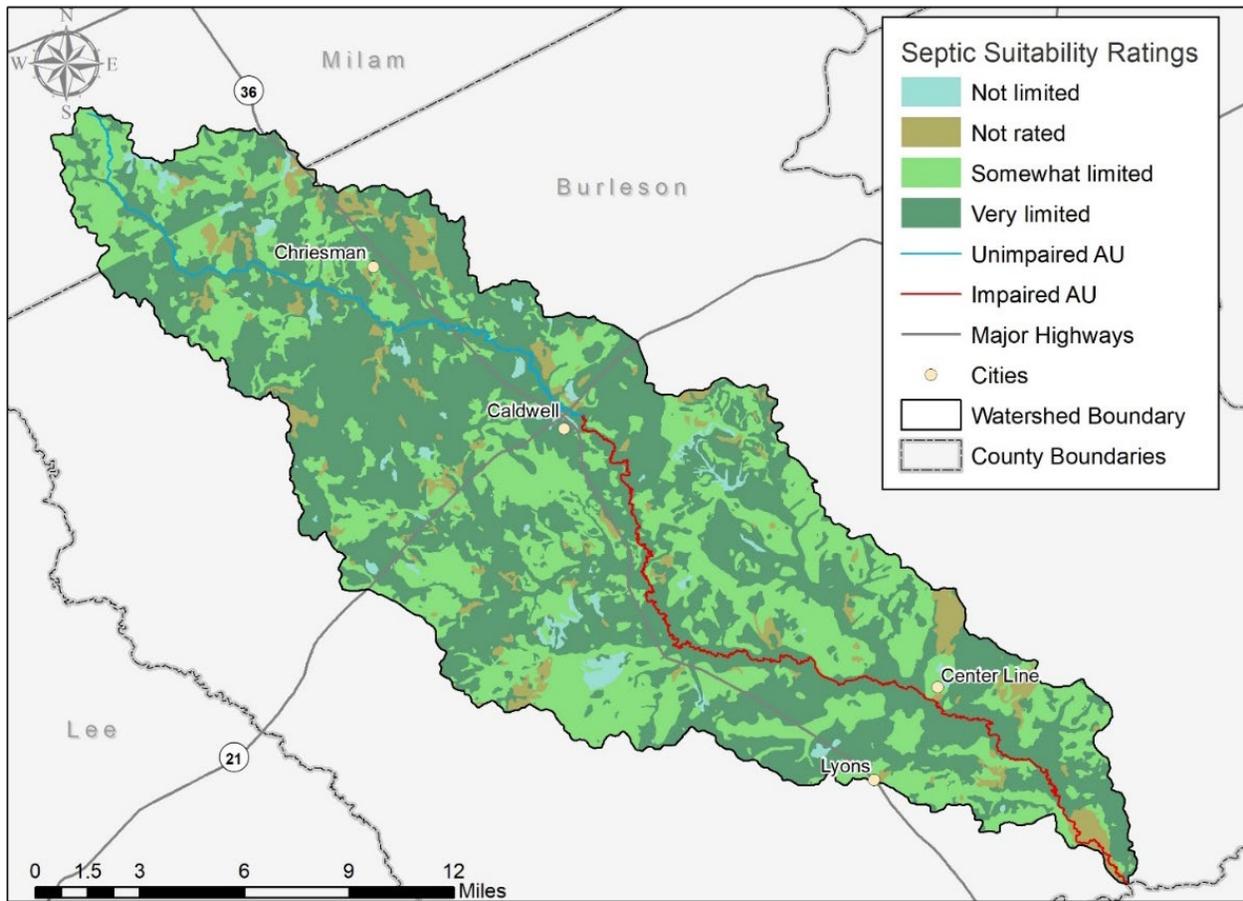
Figure 12. Davidson Creek watershed on-site sewage facility adsorption field ratings with assessment units (AUs).

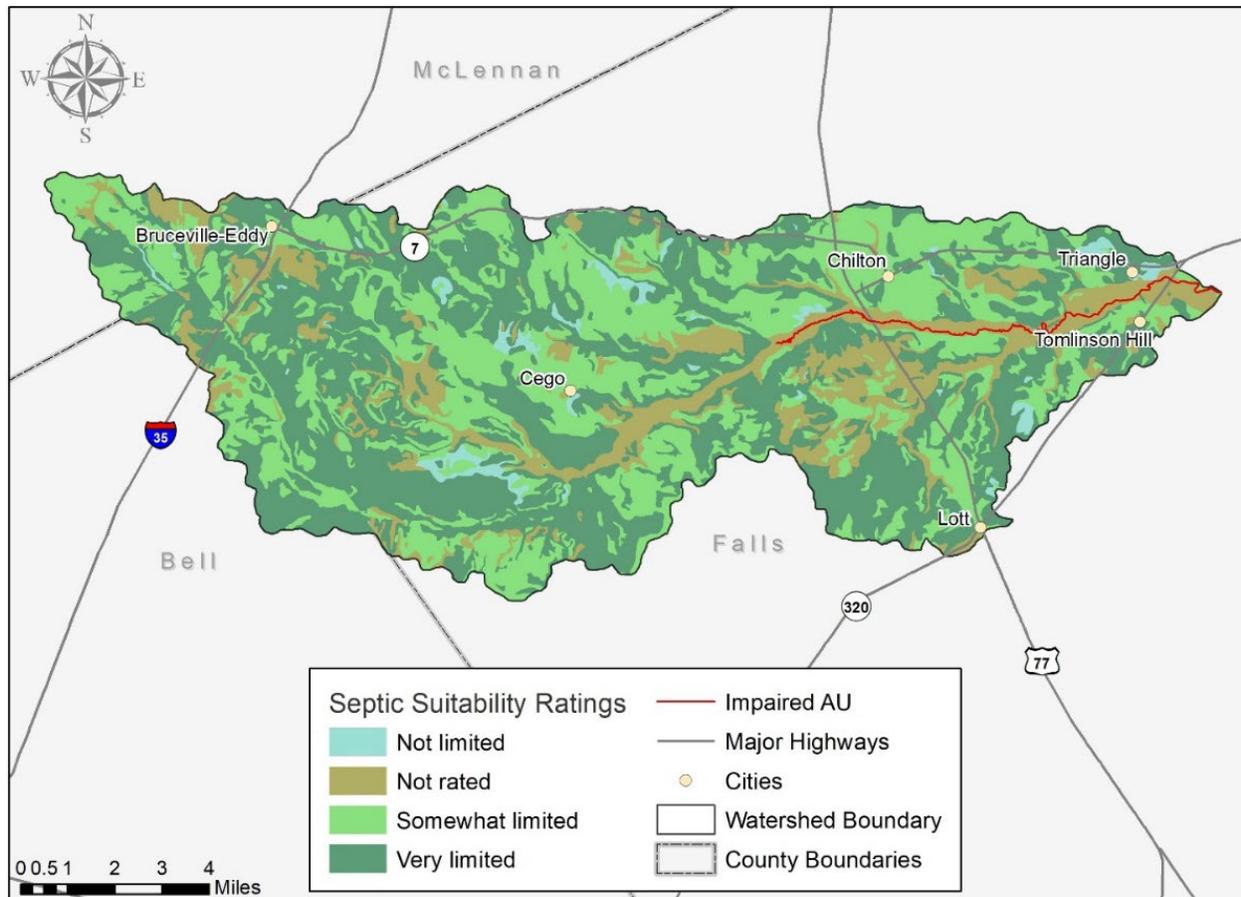
Figure 13. Deer Creek watershed on-site sewage facility adsorption field ratings with assessment units (AUs).

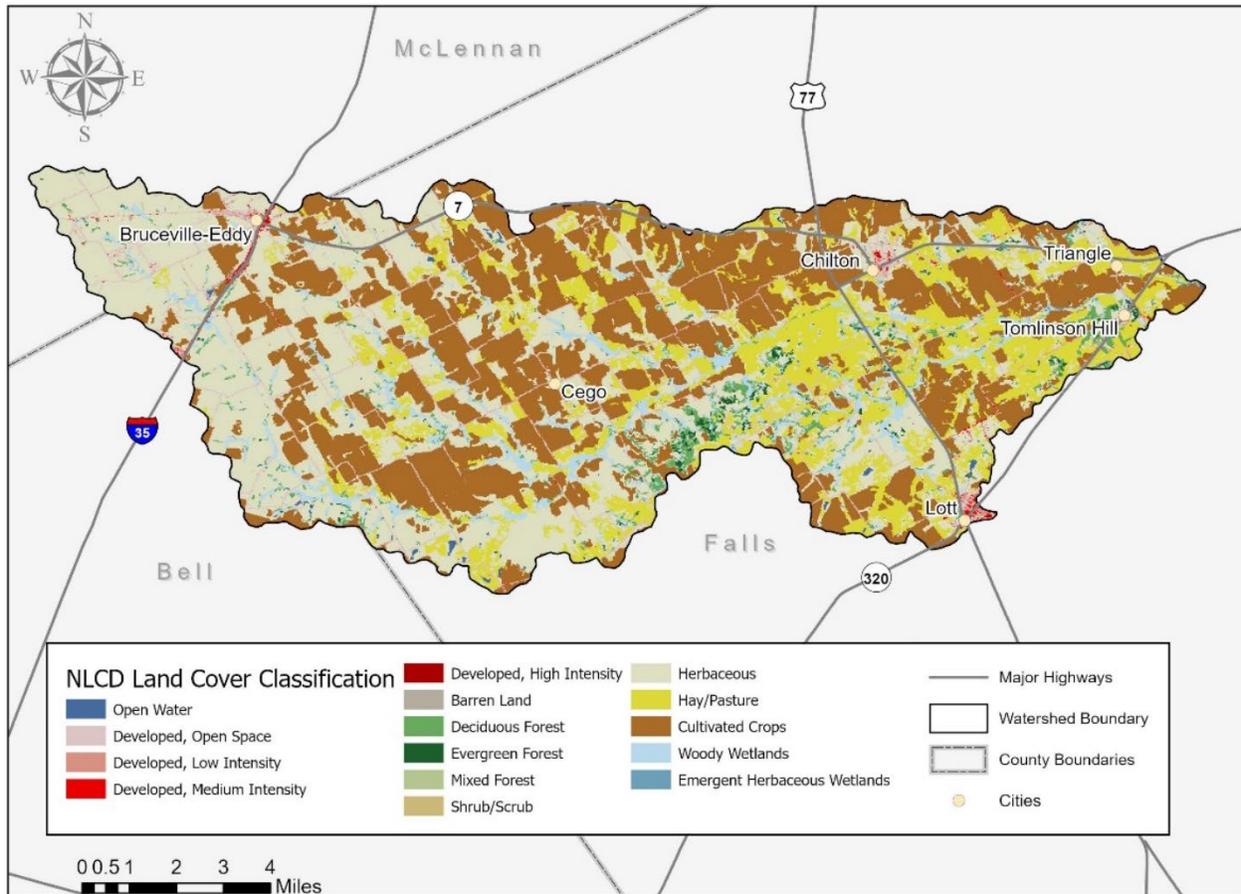
The Deer Creek watershed (Figure 19) encompasses 73,476 acres and is predominantly grassland/herbaceous (34.8%) followed closely by cultivated crops (33.8%; Table 6). Urban development comprises approximately 4,247 acres or 6% of the watershed.

Figure 19. Land use and land cover classifications from the National Land Cover Database (NLCD) in the Deer Creek watershed (MRLC 2019).

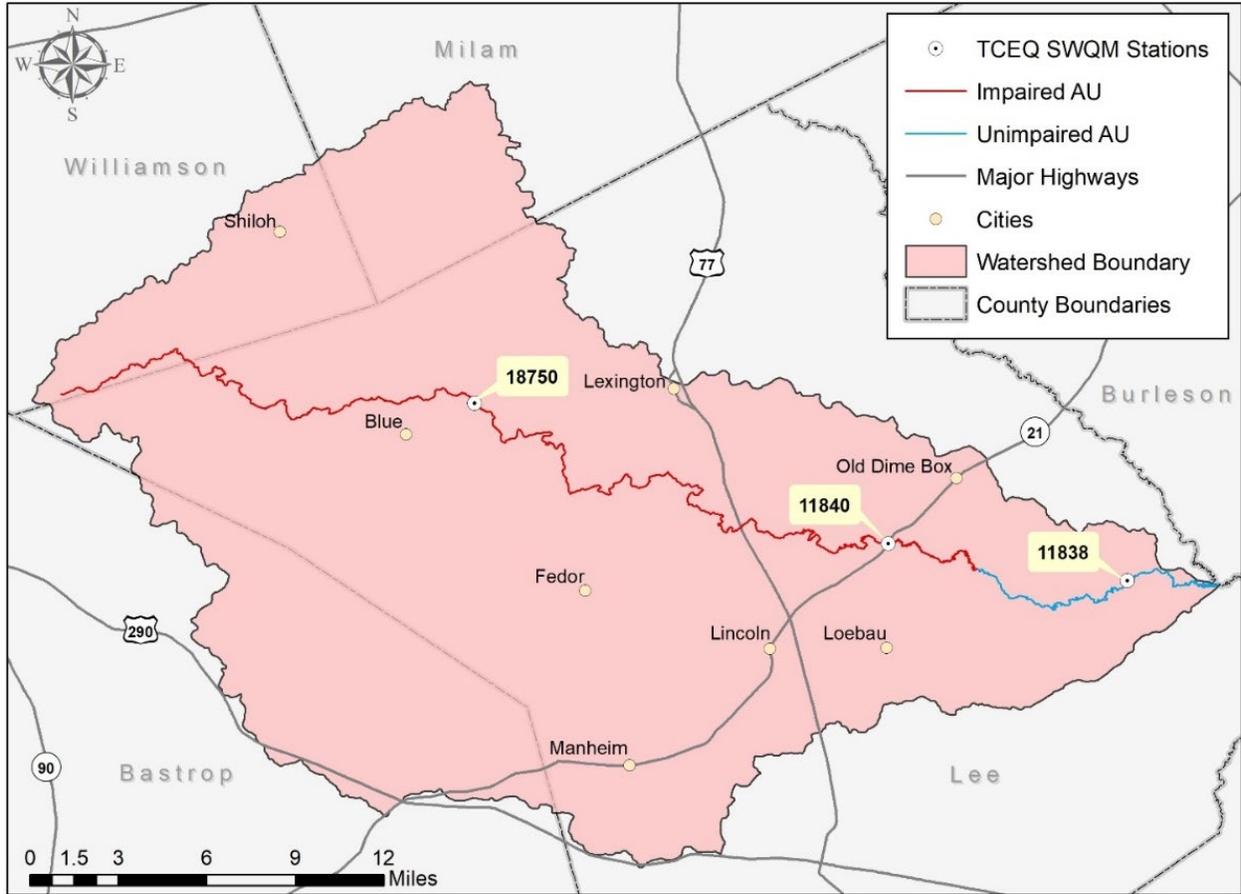
Figure 32. Surface water quality monitoring stations in the Middle Yegua Creek watershed with assessment units (AUs).

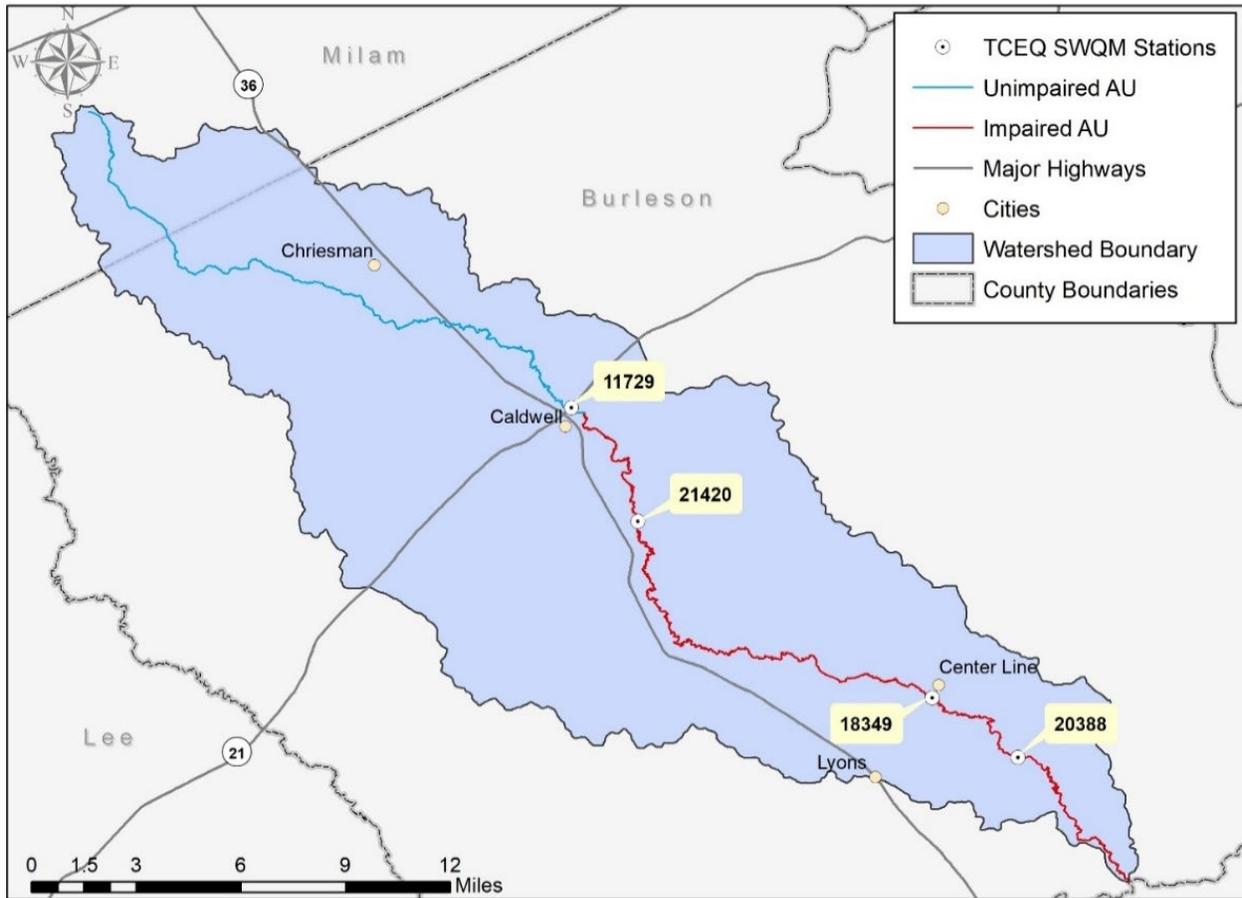
Figure 33. Surface water quality monitoring stations in the Davidson Creek watershed with assessment units (AUs).

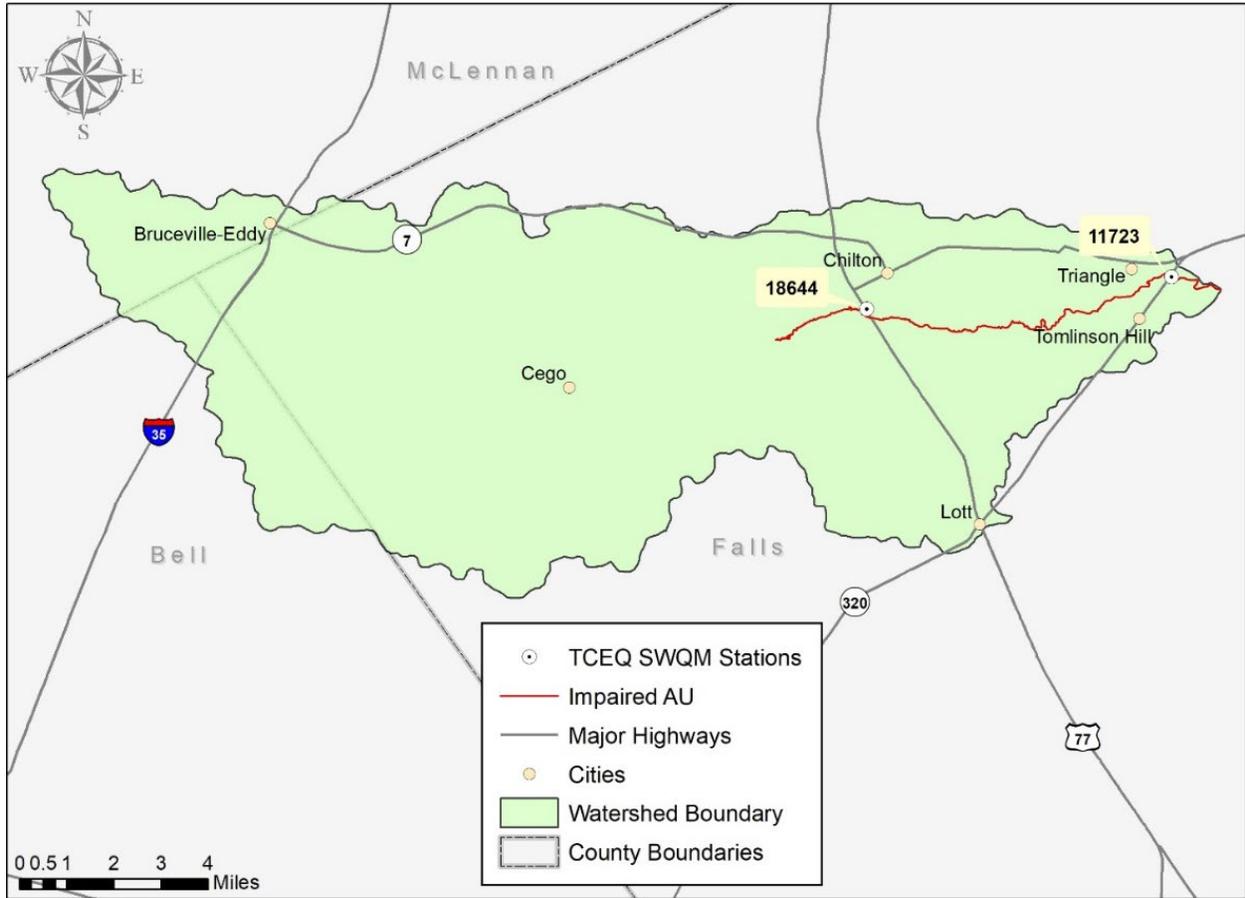
Figure 34. Surface water quality monitoring stations in the Deer Creek watershed with assessment units (AUs).

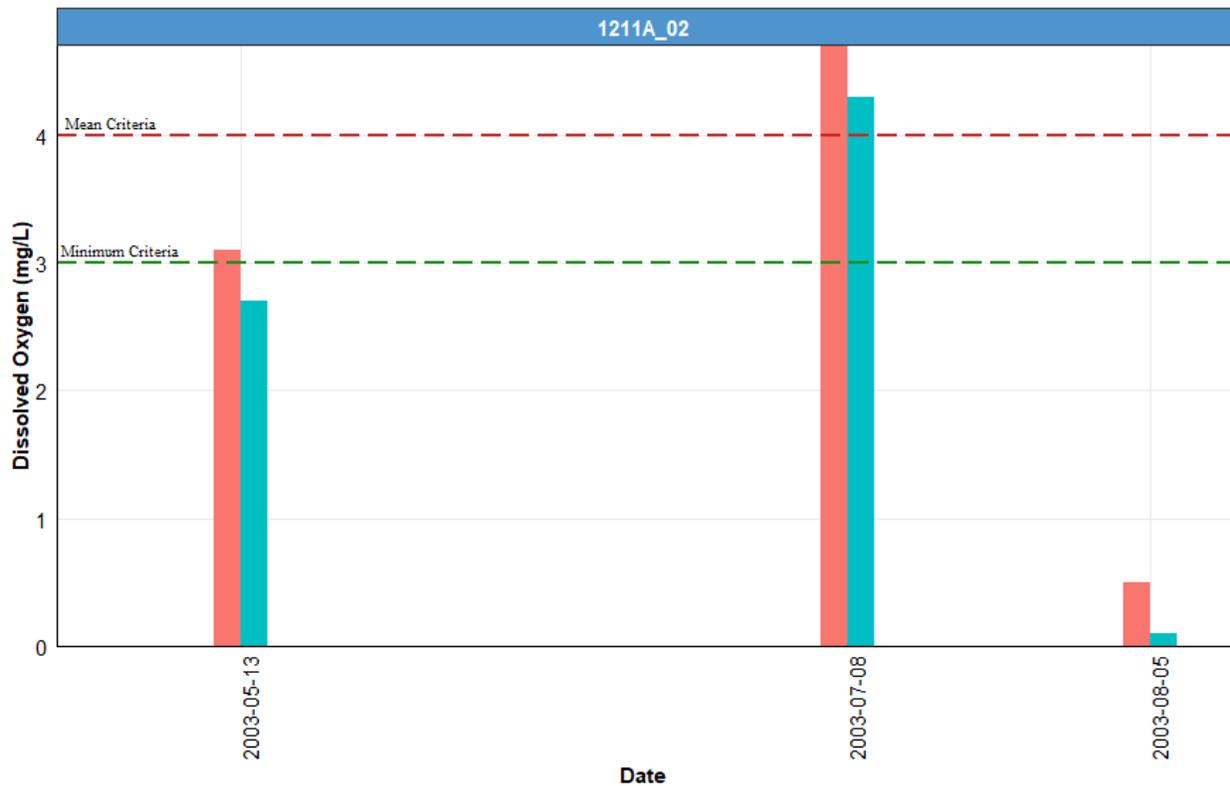
Figure 38. Historical 24-hour dissolved oxygen concentrations for the Davidson Creek watershed station 20388. The orange bar indicates average 24-hour dissolved concentrations, and the blue bar indicates minimum 24-hour dissolved oxygen concentrations.

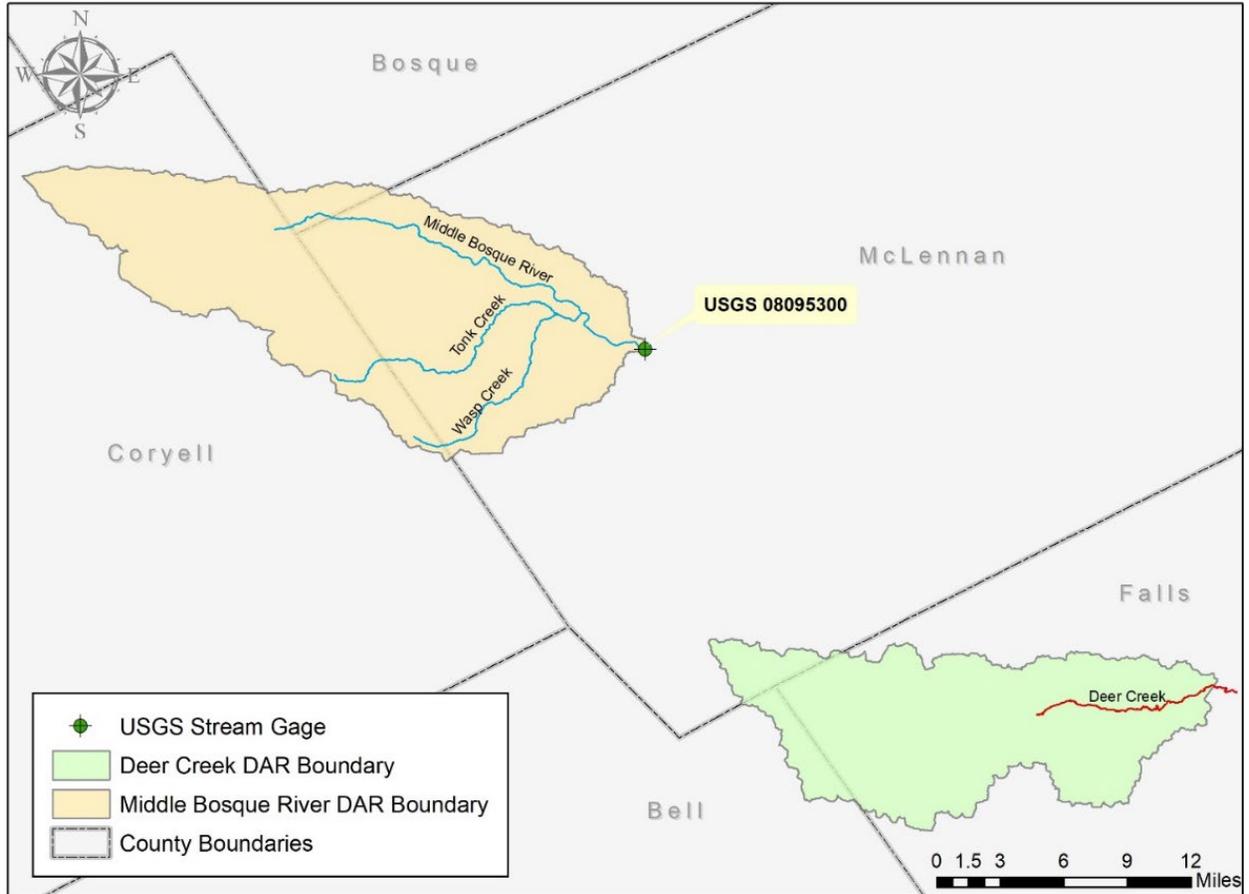
Figure 46. U.S. Geological Survey (USGS) streamflow gage and watershed used in streamflow development for Deer Creek.

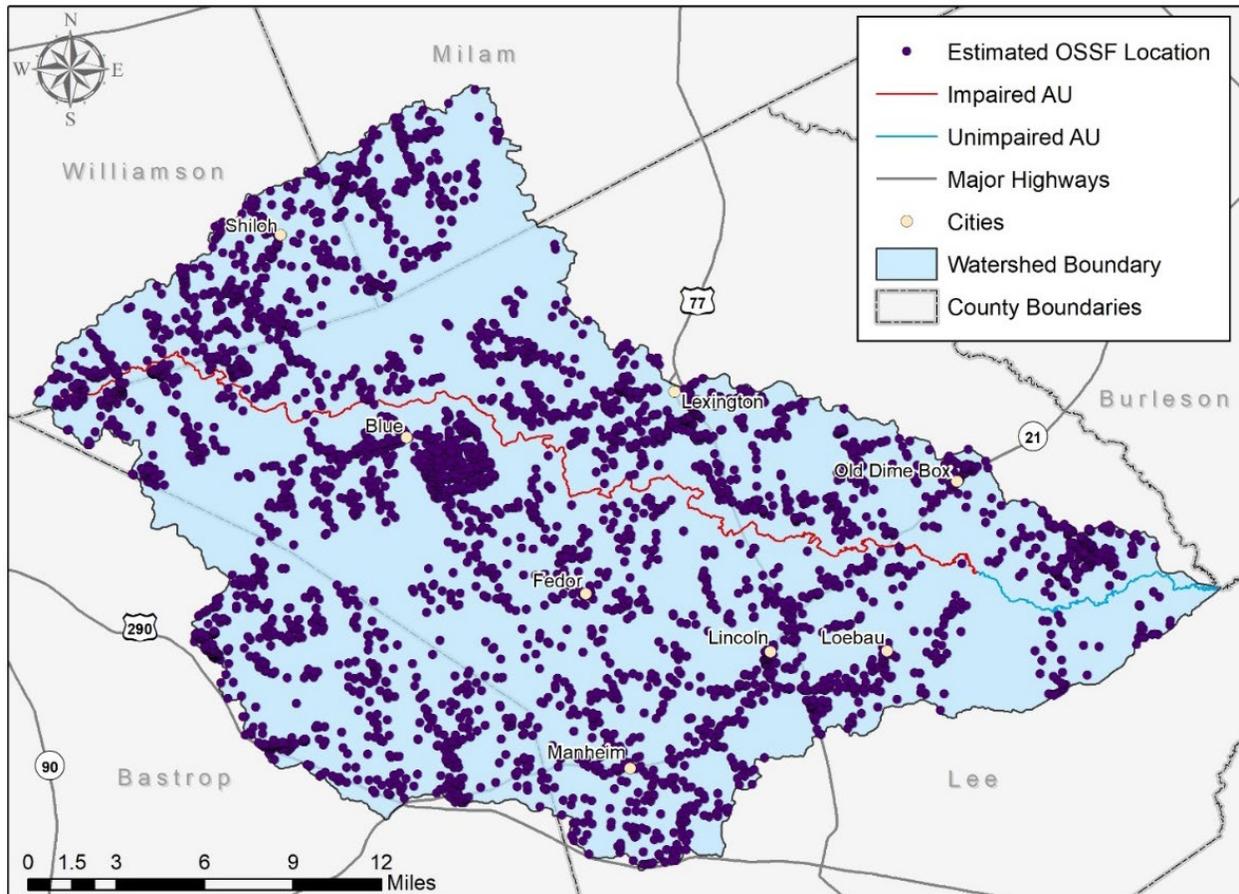
Figure 48. Estimated on-site sewage facility (OSSF) locations in the Middle Yegua Creek watershed with assessment units (AUs).

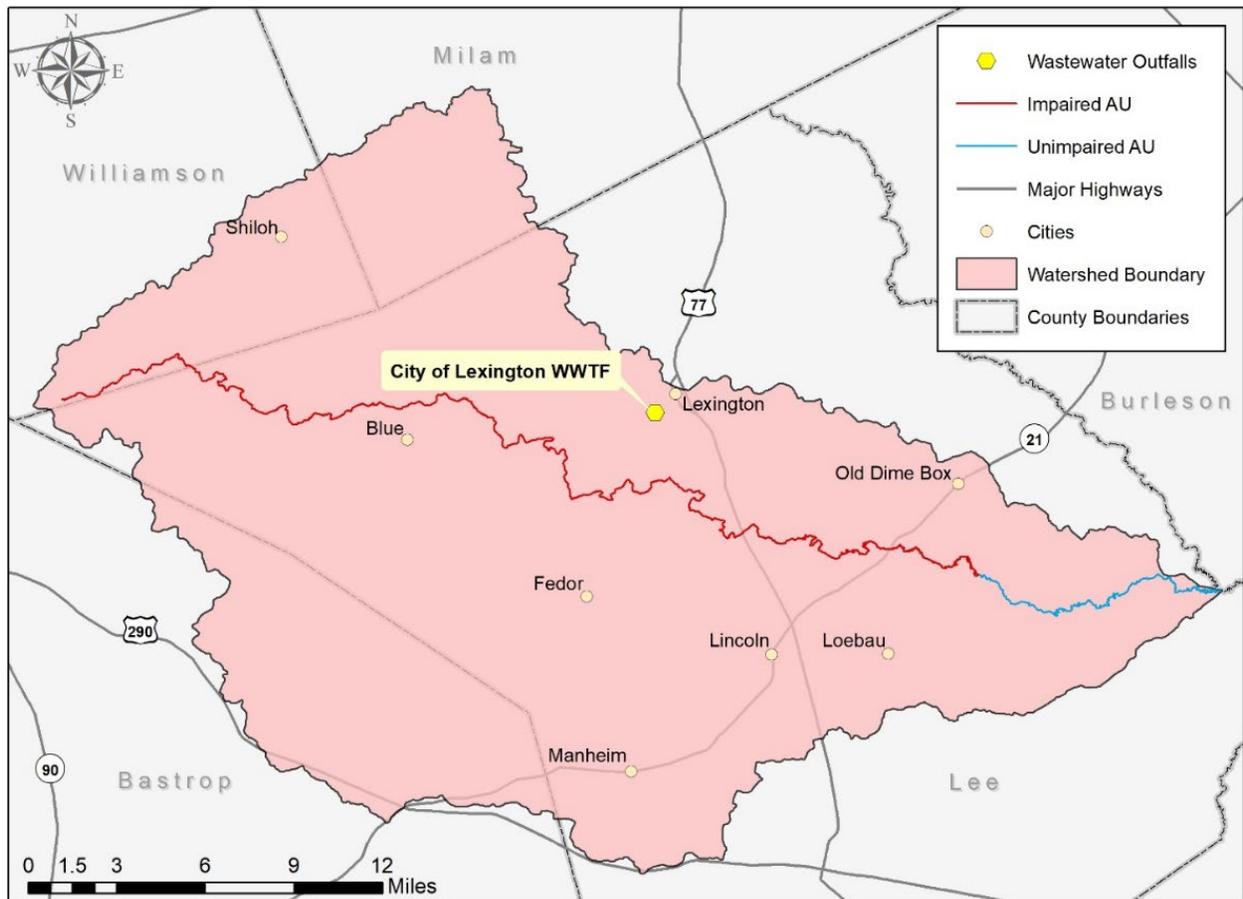
Figure 51. Active permitted wastewater discharge outfall locations for the Middle Yegua Creek watershed with assessment units (AUs).

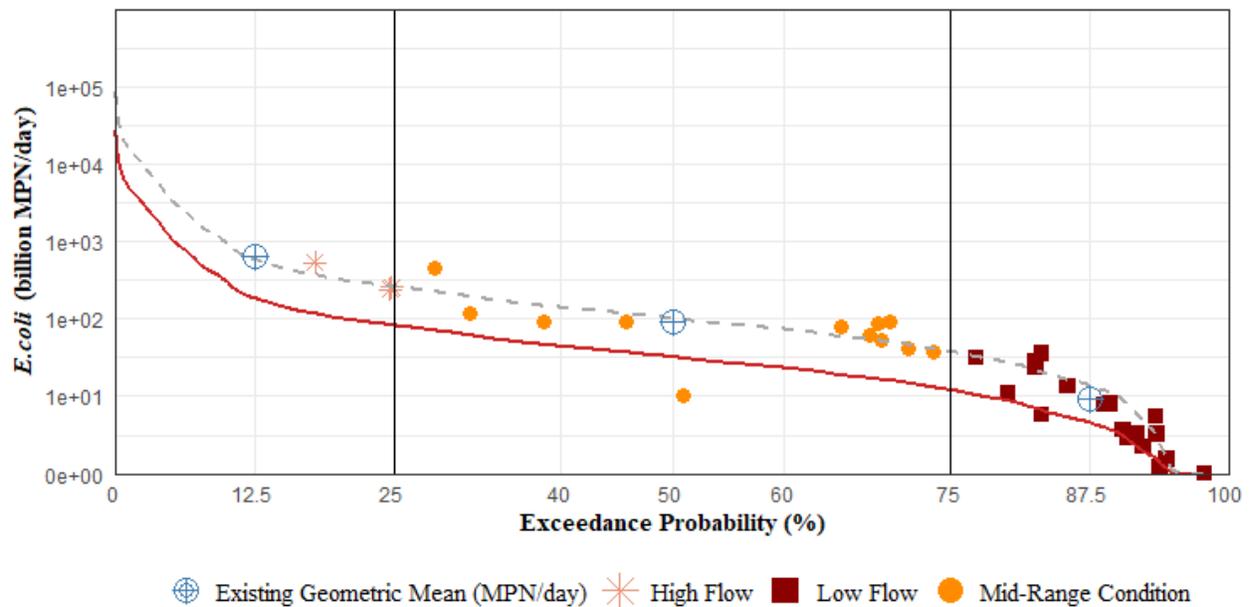
Figure 54. Load duration curve for Middle Yegua Creek surface water quality monitoring station 18750. The solid red line indicates the allowable load at geomean criterion (126 most probable number [MPN]/100 milliliters [mL]) and the grey dashed line is allowable load at single sample criterion (399 MPN/100 mL).
