Continued Surface Water Quality Monitoring for Middle Yegua Creek, Davidson Creek and Deer Creek Watersheds Final Report

Continued Surface Water Quality Monitoring for Middle Yegua Creek, Davidson Creek, and Deer Creek Watersheds Final Report

TSSWCB Project #20-54

Characterization of Middle Yegua, Davidson, and Deer Creeks Watersheds

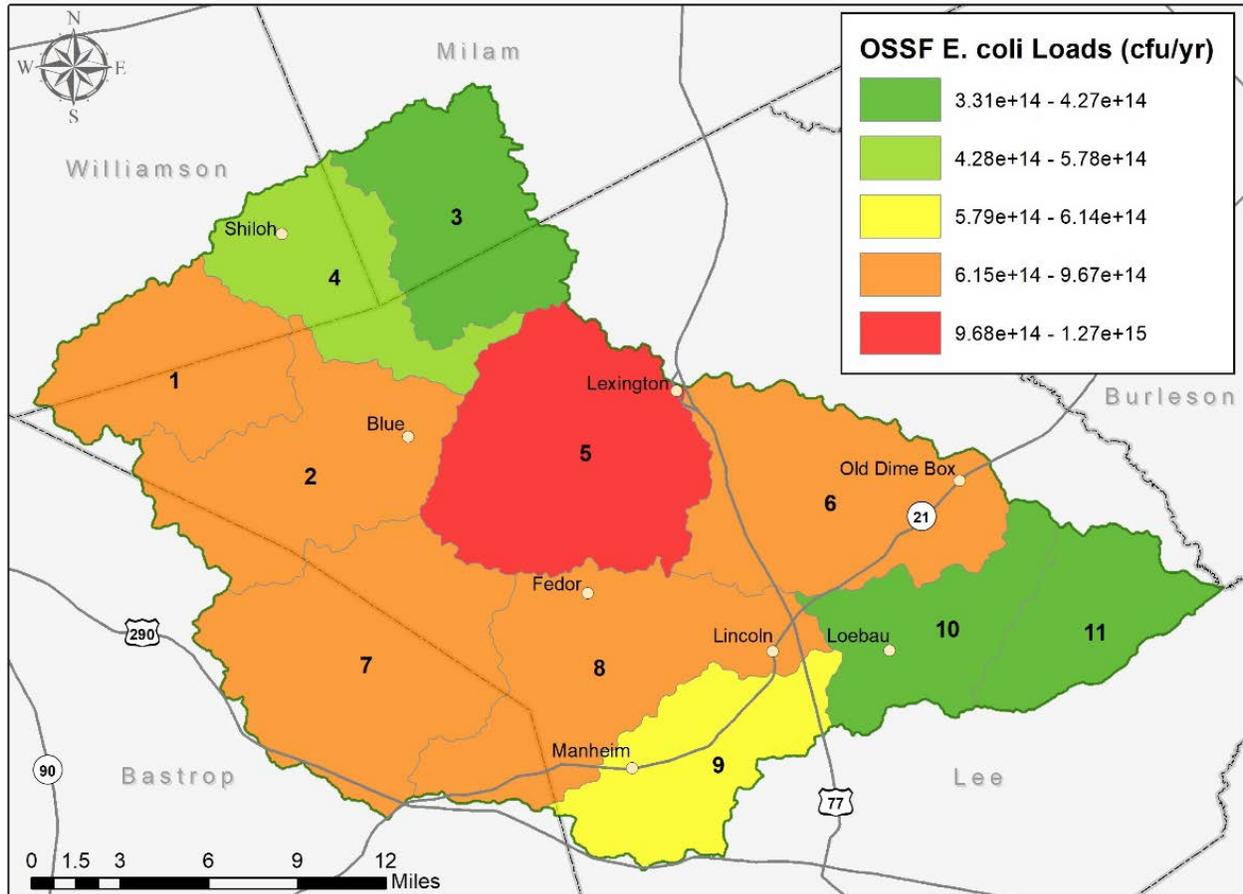
Figure 83. Potential annual bacteria loadings in colony forming units (cfu) per year (yr) from on-site sewage facilities (OSSFs) in the Middle Yegua Creek watershed.

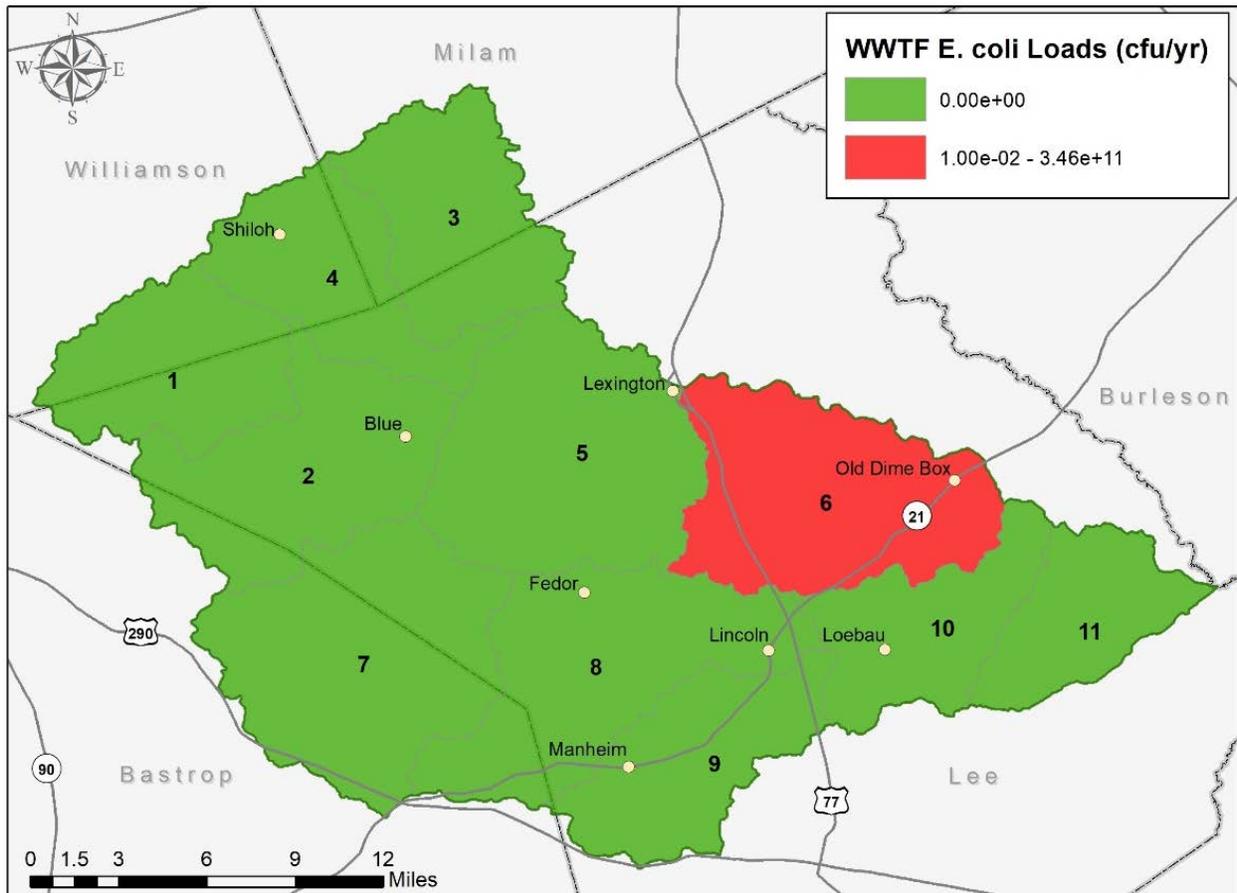
Figure 89. Potential annual bacteria loadings in colony forming units (cfu) per year (yr) from wastewater treatment facilities (WWTFs) in the Middle Yegua Creek watershed.
