Little River Continued Surface Water Quality Monitoring: Final Report and Data

Texas Water Resources Institute TR-558 October 2024

Texas Water Resources Institute Technical Report - 558

TSSWCB Project 23-50

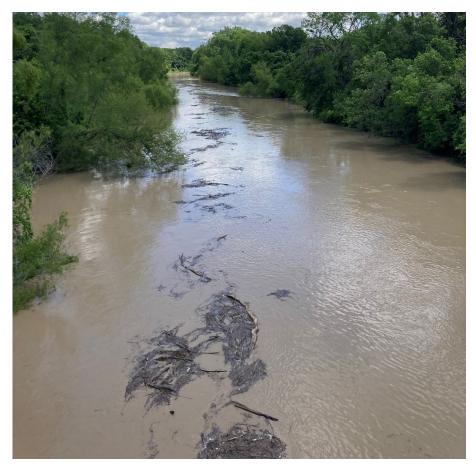
Figure A-5. High flow at site 11887 on April 27, 2023

Historical flow data indicates baseflow in Little River is approximately 100 cfs, but flow can fluctuate greatly as seen in Figure A-6 and Figure A-8. This influx of water is most likely due to rain events, the influence of wastewater inflows, and water releases from upstream reservoirs. Occasionally, high flow events prevented collection of flow measurement at site 11887 due to loss of bank access. Streamflow estimates were reported in place of flow under these conditions (Figure A-5).
